# NAVAL POSTGRADUATE SCHOOL

## PROGRESS REPORT

THE RESPONSE AND FAILURE MECHANISMS OF  
CIRCULAR METAL AND COMPOSITE PLATES  
SUBJECTED TO UNDERWATER SHOCK LOADING

01 October 1988 - 30 September 1989

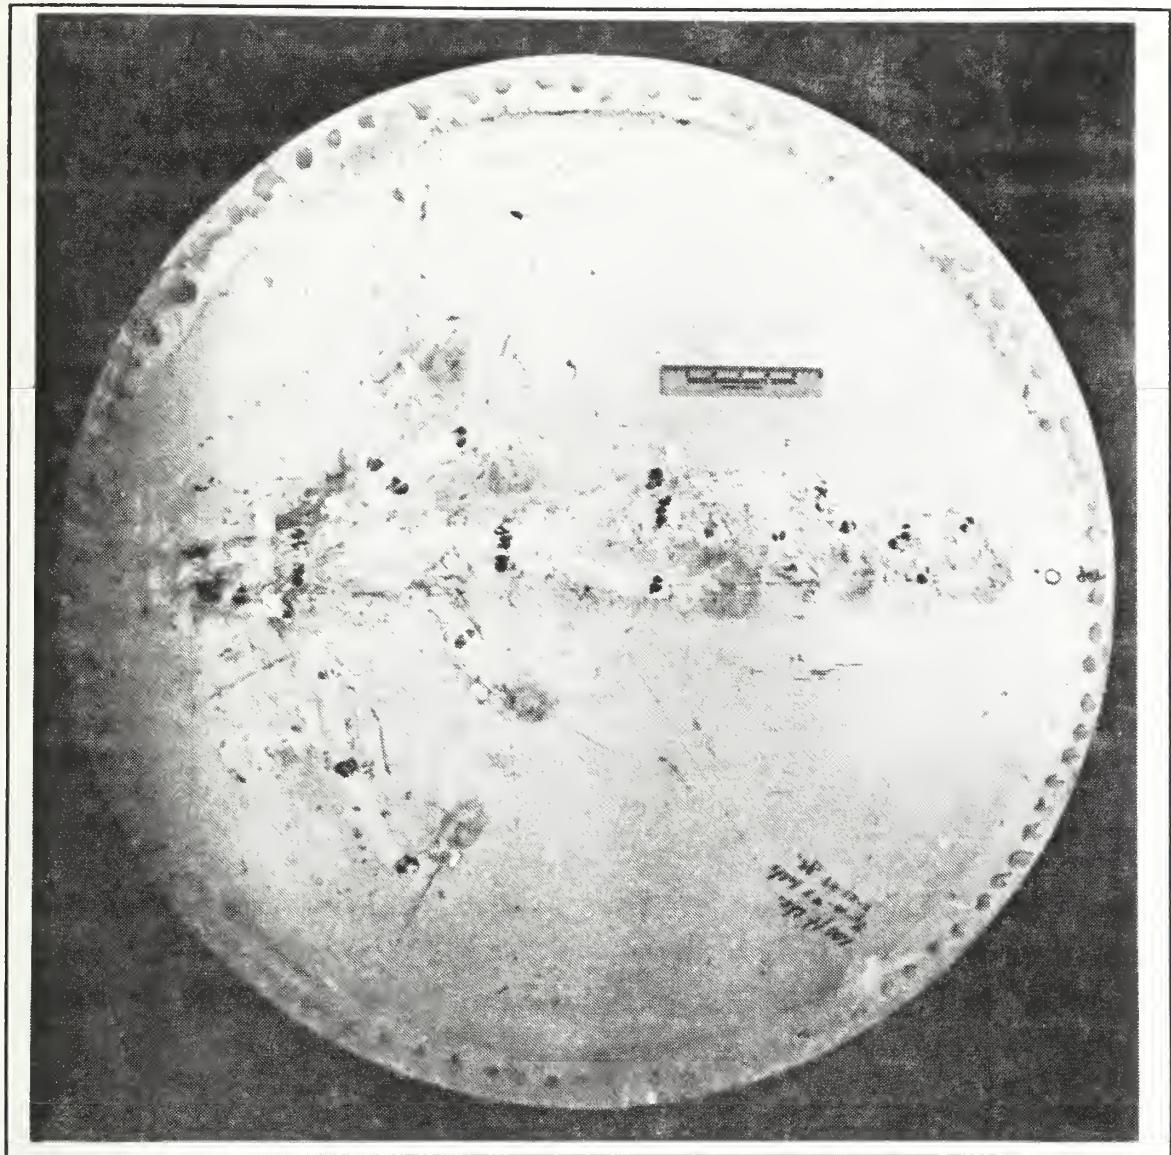
The water backed test panels showed little or no damage from the underwater explosions regardless of the charge weight used. As shown by Figure 22 the aluminum plate of test T1W was unaffected by the shock wave produced by five pounds of TNT. No noticeable deformation was noted in the composite plates subjected to the shock from five pounds of TNT in test T2W and to the shock from ten pounds of TNT in test T3W. The most significant effect on the water backed panels was noted in the composite panel from test T2W. A crescent shaped internal delamination located at the top of the panel was

**Figure 22.** The Aluminum Panel From Test T1W.

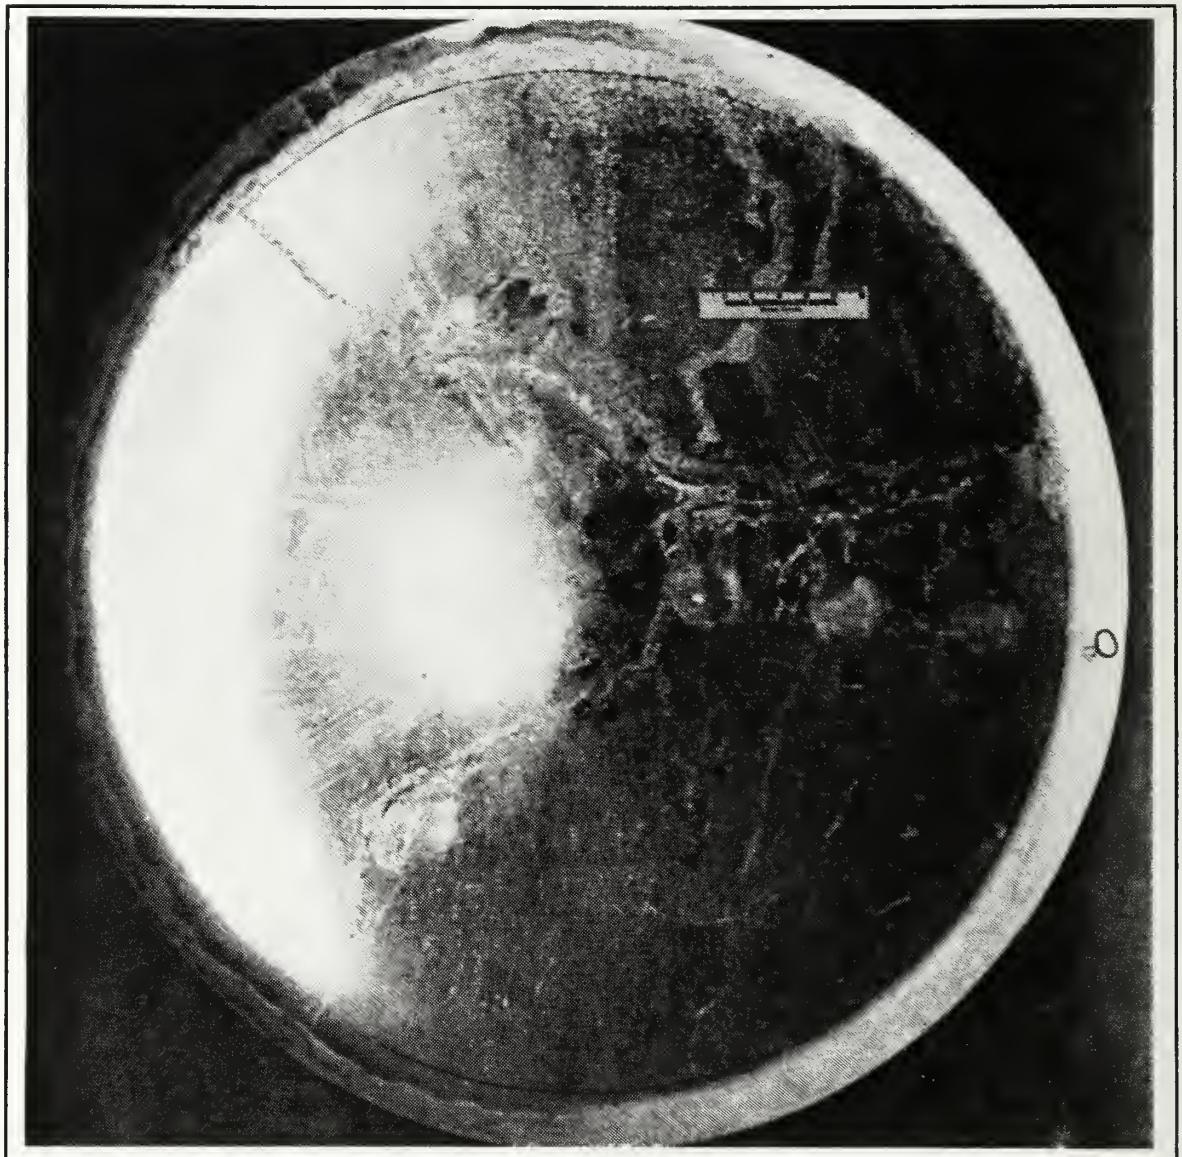
**Figure 25.** The Aluminum Panel From Test T1A.

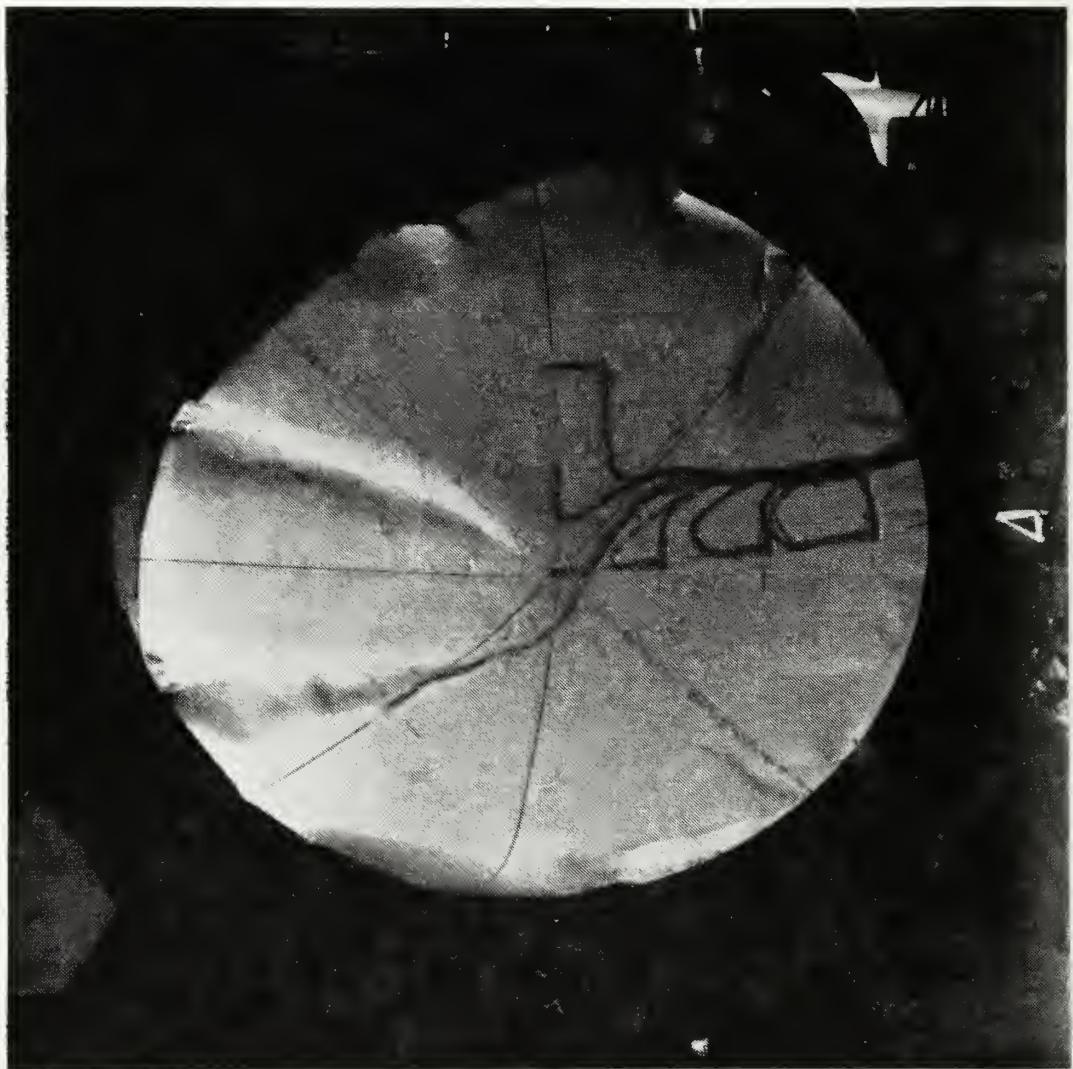
The composite panels subjected to the shock wave from the ten pound charges used in tests T3A and T4A-2 deflected to such an extent that one edge of the panel was pulled free of the clamp rings. When this occurred the panels were forced into the bottom

of the test fixture. Figure 29 shows the test panel from T4A-2 while still in the test fixture. One mode of failure for these panels was still the radially oriented strips of localized matrix rupture apparently due to compressive stresses in the circumferential direction. Superposed on this failure mode was a second mode consisting of generalized

**Figure 29.** View of the Test Panel From T4A-2 Immediately Following the Test.
